Performance of the Low-energy House in Sisimiut.

Published in:
COLD CLIMATE HVAC 2009

Performance of the Low-energy House in Sisimiut

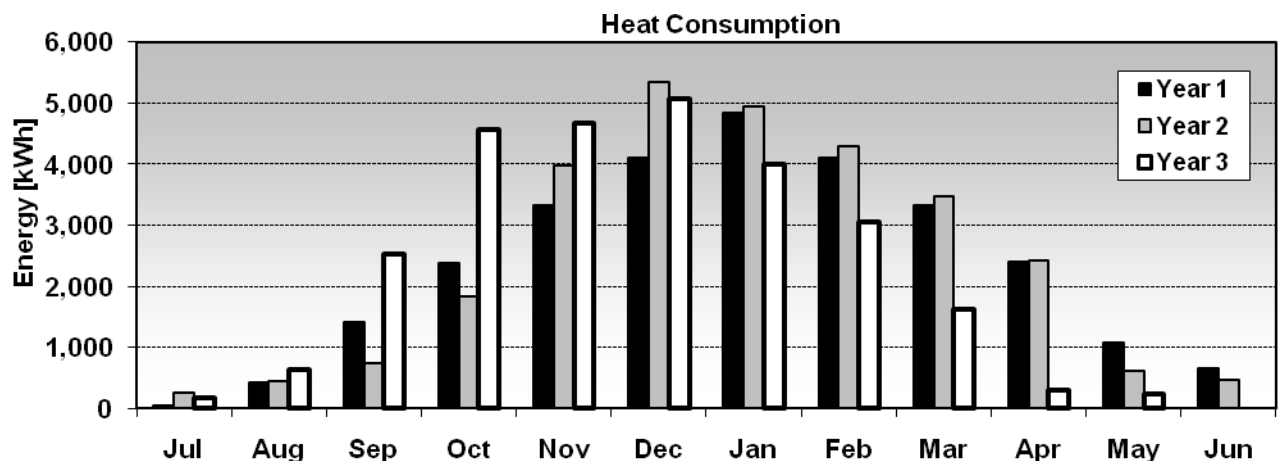
Figure 4 shows the monthly energy consumption for heating (exclusive of domestic hot water), where year 1 is for the period July 2005 – June 2006. The house has not been inhabited during the period July 2007 – April 2008 during which period the house underwent some renovation activities: A separation wall was erected in the boiler room, and the wooden floor of the living rooms was changed because of a failure with the first delivered floor. The house was heated during the construction period, although in a somewhat unusual pattern.

Figure 4. Heat consumption during the months of the first three full years of operation.

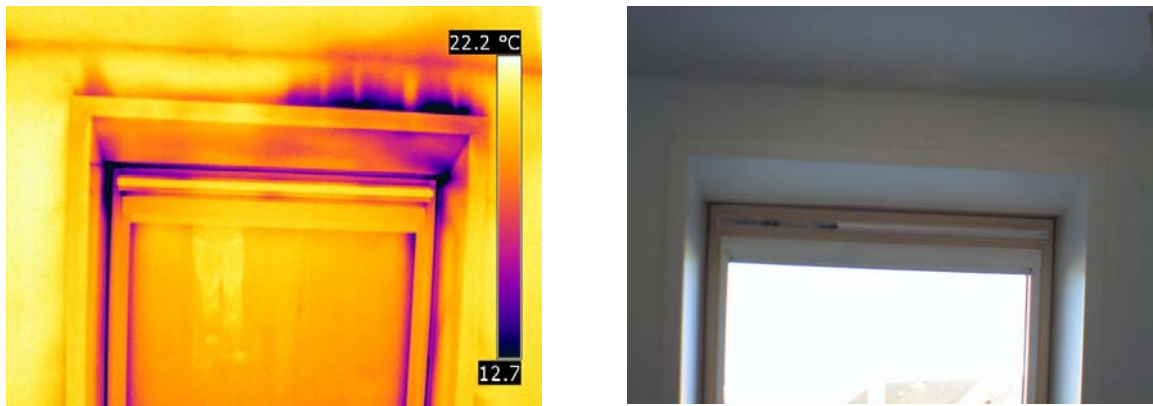
A so-called blower door test has been carried out on February 7, 2009. The test showed an average leakage of 3.2 h^{-1} measured at 50 Pa over- and under-pressure. While this air leakage is not too high compared to the Greenlandic Building Code, since there are no requirements, it is significantly above the requirement imposed since 2006 in the Danish Building Code, that the air change must not exceed 1.5 h^{-1} when measured at 50 Pa pressure difference. Problem areas were identified around windows, at floor joints, at electrical outlets, and possibly under the floor (see Figure 5).

Figure 5. Infrared and normal picture of north-west facing window taken during blower door test.

For a building which is not in a sheltered environment, it can be expected that the free air change due to infiltration/exfiltration, n_{inf} is around 10% of n_{50} (DIN, 2003) and thus infiltration/exfiltration in the house can be expected to be around 0.32 h^{-1} . The volume of air in the building is 530 m^3 , and thus the annual ventilation heat loss associated with this air change can be estimated to be 68 kWh/m^2 (based on the average outdoor temperature: -3.9°C). The assumption when designing the house was that the infiltration/exfiltration air flow would be only 0.1 h^{-1} , and thus the annual extra energy consumption due to poor air tightness of the building envelope, amounts to approximately 45 kWh/m^2 .
